NUTS AND BOLTS

Timing chains, tensioners and peace of mind

... FOR MODELS BETWEEN 1996 AND 2002

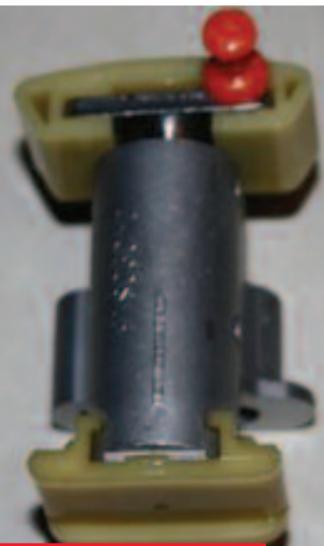
Close up of latest fourth generation metal timing chain tensioner

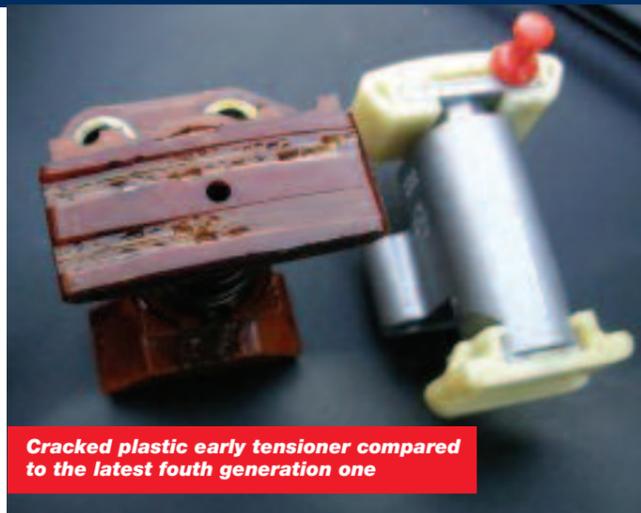
have to endure sooner or later they can crack and begin to break up allowing chain contact with the metal inner support. This can then potentially lead to the chain slipping by a cog. A grinding noise on start up of a cold engine could be indicative that this has happened in which case the damage will have been done.

Cracked plastic early tensioner compared to the latest fourth generation one

Jaguar recognised the above problem and changed the design over four generations finally using a more conventional metal type of tensioner as fitted to the 4.2 XK8/XKR engine. High mileage/early cars may well of had the tensioners and possibly the associated chains and guides replaced but if not then it's advised to have them checked as soon as and if required replaced with the later parts.

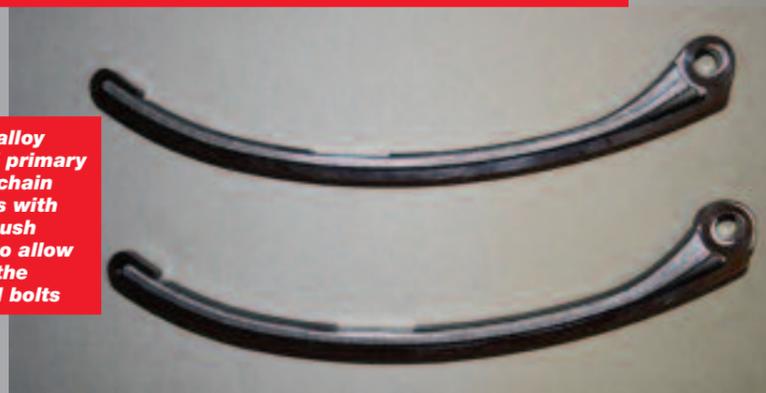
Latest alloy backed primary timing chain slippers with small bush insert to allow use of the original bolts

Another problem with the early engines relates to the use of bonded plastic slippers and guides. Each lower (primary) timing chain is tensioned by it's own tensioner and this reacts against a slipper over which the chain runs over the guide on the other side.

These are also prone to cracking but experience shows that this is far less of a problem than the failure of the upper tensioners. However it is advisable that if the lower tensioners are to be replaced then the guides and slippers should also be replaced.

However, the guides and slippers have been redesigned by an original equipment manufacturer so that they will now fit the earlier engines providing that the latest metal
