NUTS AND BOLTS

Timing chains, tensioners and peace of mind

... FOR MODELS BETWEEN 1996 AND 2002

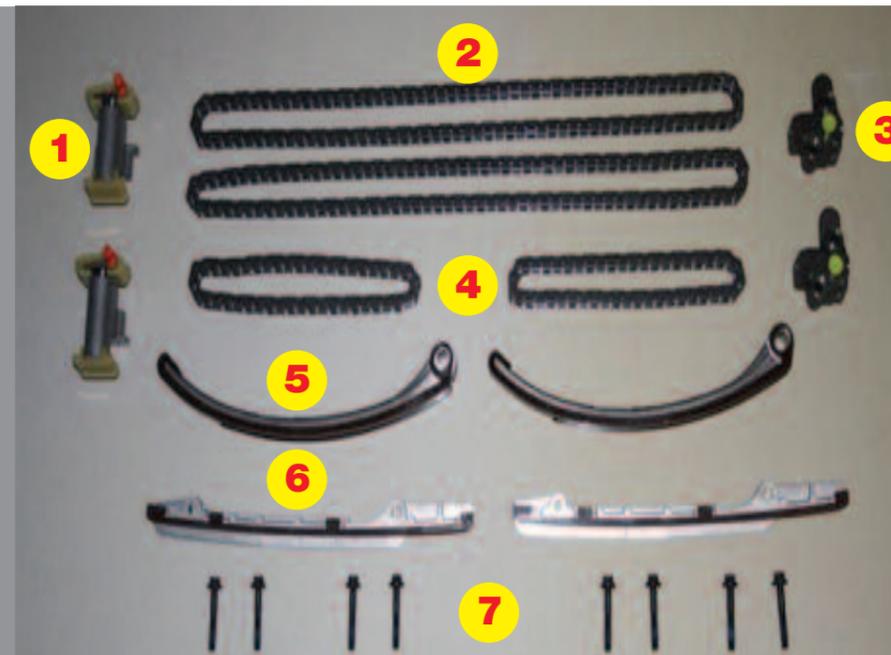
1 Top tensioners 2 Primary (bottom) chains 3 Bottom tensioners 4 Secondary (top) chains 5 Primary chain guides 6 Primary chain guides 7 Top and bottom chain tensioners bolts

Latest alloy backed primary timing chain slippers with small bush insert to allow use of the original bolts

If not then I would suggest that this job be done as soon as possible and in view of the problems reported here then a full timing and tensioner overhaul be done. If you have a 2000 to 2002 model year car I would recommend that at least the top tensioners and chains be checked and replaced with the later fourth generation parts.

There is a kit consisting of the parts to do just this. However, depending on the cars mileage you might just want to go the whole hog and replace all the timing chain and tensioner parts as part of a good servicing schedule for your car.
