NUTS AND BOLTS

XK8 and XKR front suspension bushes and subframe issues

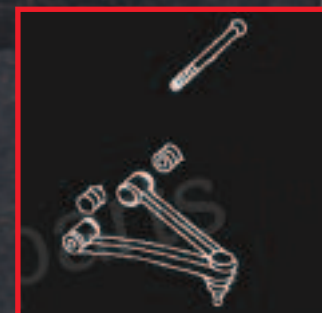
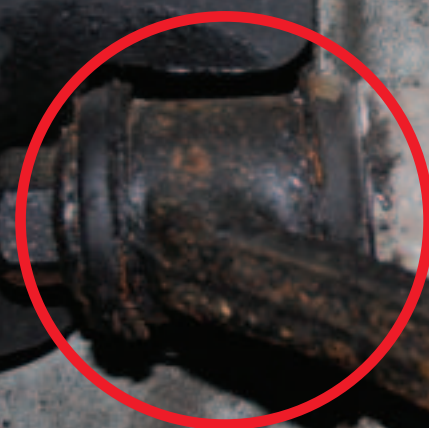
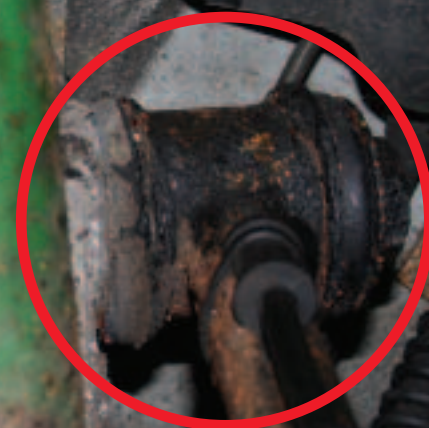
Bushes, circled, and inset, diagram showing the assembly of bushes and wishbone

A more extreme – and potentially a much more expensive – problem with knocking from the top wishbone arm area is due to the top wishbone bushes seizing to the steel fulcrum pin connecting the wishbone arm and subframe together.

At each pin hole end, this is hollowed out and this allows water, dirt and salt etc to ingress into the hole and corrode the bush and pin. No protection is provided for the exposed area or in fact any Jaguar maintenance advice to periodically clean and protect the area with grease or waxoyl.

The top front and rear bushes are designed to self lubricate and rotate as required around the fulcrum pin. However, when these become corroded, the combined seized unit then wears away at the aluminium subframe.
